Manhole Inspection Summary

Manhole # S02YY1014MH

Insp Date: **10/24/06 11:28 PM**

Location Address: **6400 park heights ave**

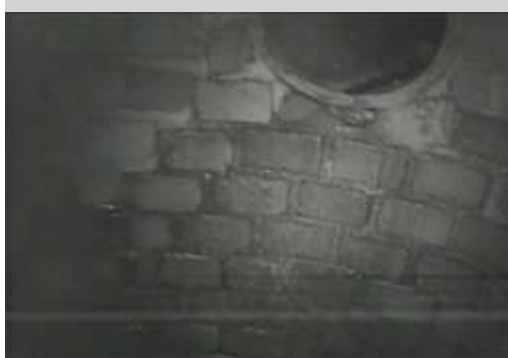
Defect

Infiltration: ☐ None ☒ **Joint** ☐ Cracks ☐ Mortar ☐ Roots ☐ Wall

infiltration of barrel

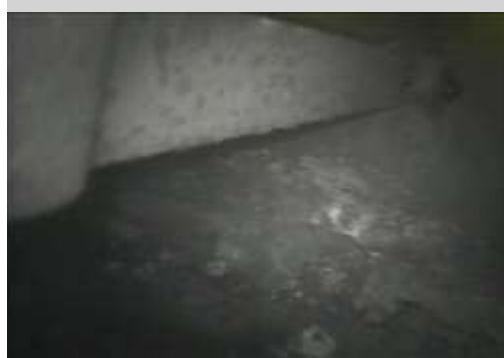
Defect

Infiltration: ☐ None ☐ Joint ☐ Cracks ☐ Mortar ☐ Roots ☒ **Wall**

INFILTRATION OF CHIMNEY WALL

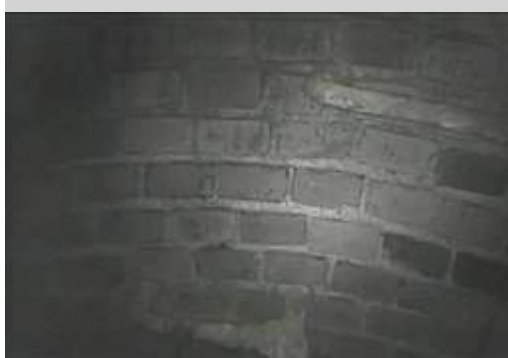
Defect

☒ **Evidence Of Surcharge** Depth: **4** (ft.) ☐ Active Surcharge Present

evidence of surcharge

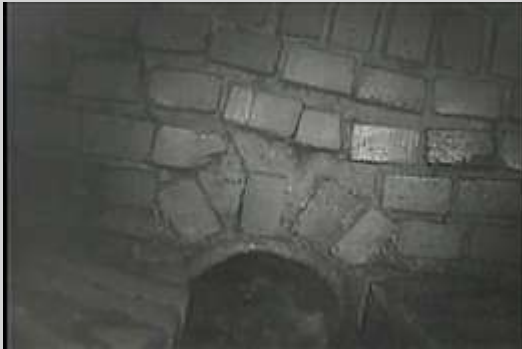
10 in. Circular Gravity Sewer Pipe Out @ 12 O'Clock

Infiltration: **Evidence** Pipe Seal Cond: **Sound**
